PROBLEMS ASSOCIATED WITH ATTACHING STRAIN GAGES

TO TITANIUM ALLOY Ti-6A1-4V

Jerald M. Jenkins Dryden Flight Research Center

February 1977

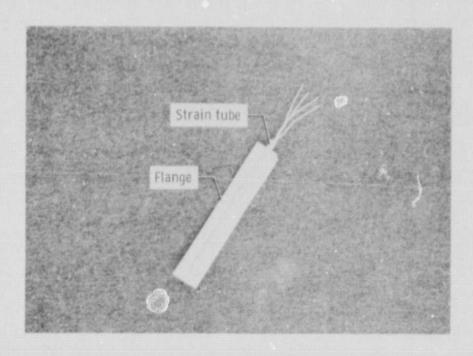
Figure 1. Weldable strain gage.

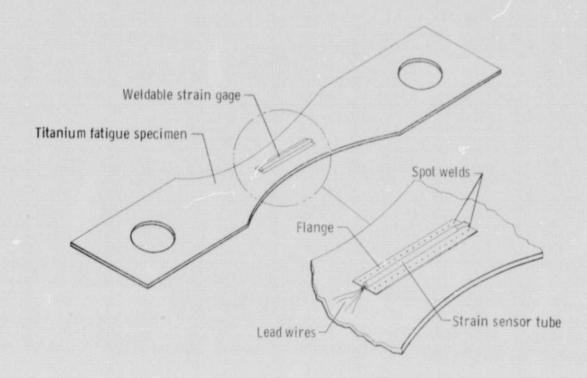
In the tests reported in references 2 to 4, spotwelding was used to attach strain gages to fatigue specimens of titanium alloy Ti-6Al-4V (fig. 2). The subsequent fatigue tests showed the fatigue life of the titanium to be reduced so severely as to preclude the use of this strain gage attachment method on aircraft.

Figure 2. Strain gage spot welded to Ti-6Al-4V fatigue specimen.

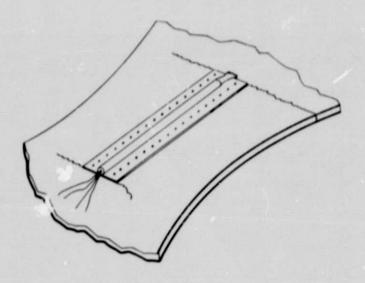
It was observed during the Battelle Columbus Laboratories' fatigue tests that the first fatigue cracks occurred near or at the ends of the strain gage flanges, as depicted in figure 3. The consistency with which the first failure occurred near the ends of the gage flange suggests that the flange causes a stress concentration that contributes to the premature failure of the specimens. An investigation was initiated to determine the ways in which the flange might be modified to reduce this stress concentration.

Figure 3. Fatigue cracks in specimen near ends of flange.

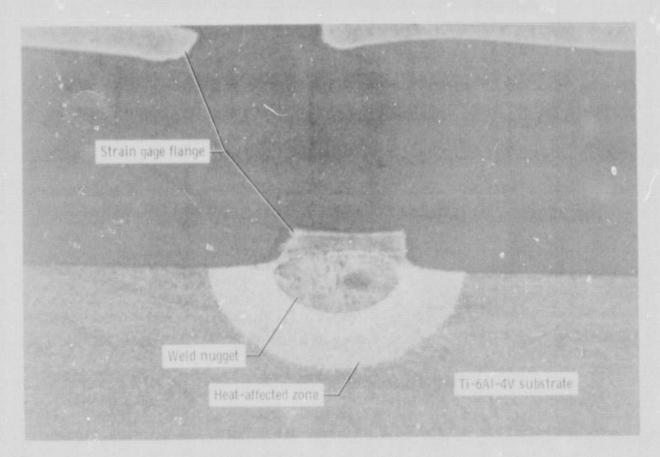
Another factor in the failure of the fatigue specimens that must be considered is that a spot weld on the surface of a metallic matrix results in a discontinuity which may be described as a stress raiser. Figure 4 shows that this type of discontinuity is caused by the local melting of the material beneath and around the spot weld. This change in the microstructure of the base material causes a stress concentration that plays a role in the premature failure of the fatigue specimen.

Figure 4. Photomicrograph of strain gage flange spot weld. Substrate is Ti-6Al-4V.

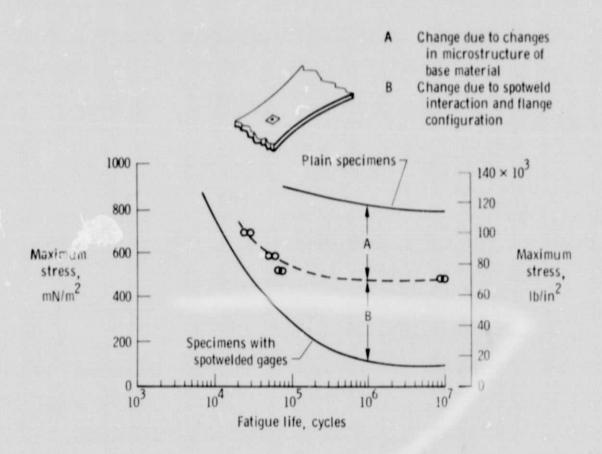
A set of tests was run to investigate the relative importance of these factors. A single small tab was attached to each of several fatigue specimens, using a single spot weld as the attachment mechanism. This provided a situation in which no gage flange loads, constraints, or other spot welds were present on the specimen. The resulting data therefore revealed the fatigue life degradation due to the changes in the microstructure of the base material resulting from the spot weld. As shown in figure 5, the spot weld alone caused a significant reduction in the fatigue life of the titanium specimens. The figure also shows the fatigue life of titanium specimens to which strain gages were attached. The data show that, in combination, the spotweld interactions and the other effects of the presence of the flange significantly reduced fatigue life.

Figure 5. Constant-amplitude fatigue data showing effect of single spot weld on Ti-6Al-4V.

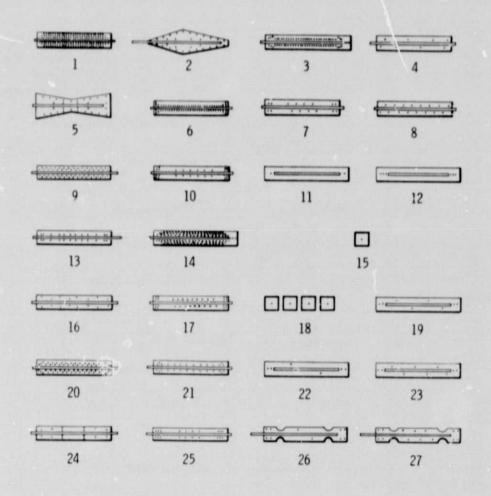
In an effort to learn the effects of the flange shape and the arrangement of the spot welds on the fatigue life of the titanium, strain gages with various flange shapes and spotweld arrangements were constructed and attached to Ti-6Al-4V fatigue specimens. The test configurations are shown in figure 6. Accelerated (i.e. flexural) fatigue tests were used so the effects of the configuration changes could be determined more quickly. All tests were conducted at the same stress level to make the results comparable. The results of the tests are documented in table 1. The effects of flange shape and spotweld arrangement were not obvious from these data. However, when the number of spot welds was plotted against the number of cycles to failure, a trend did appear. As shown in figure 7, configurations with many spot welds tended to fail slightly earlier than configurations with only a few spot welds

Figure 6. Variations in strain gage flange and spotwelding configurations.

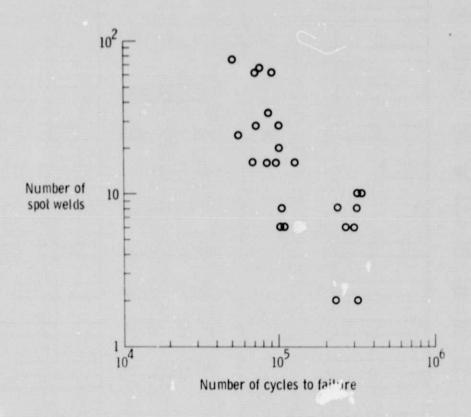
This trend is not without explanation. Configurations with many spot welds are more rigidly attached than those with fewer spot welds. The more rigid attachment causes larger stress concentrations.

Figure 7. Relationship between number of spot welds and Ti-6Al-4V specimen fatigue life.

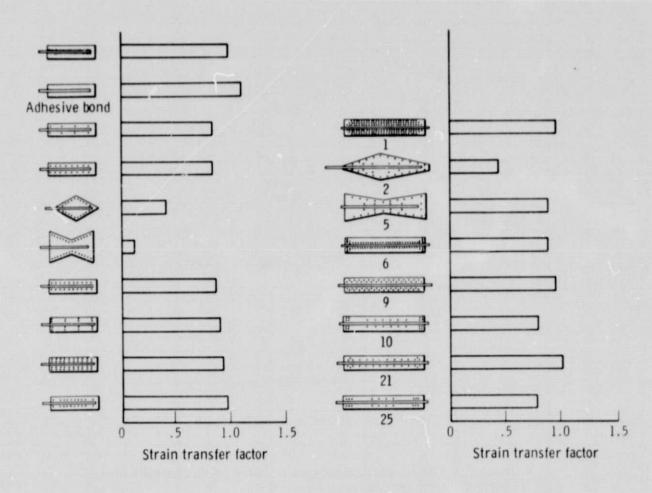
Strain transfer factors were determined for the configurations shown in figure 8. The first configurations tested are shown on the left (an adhesive-bonded gage was tested to provide a standard for comparison). Modifications were made on the basis of the test results, and several of the resulting strain gages (strain gages 1, 2, 5, 6, 9, 10, 21, and 25) were tested. Flange shapes like those for strain gages 2 and 5 resulted in generally lower strain transfer factors in both test groups. The highest strain transfer factors resulted from rectangular flanges with many spot welds, but these configurations also resulted in the poor fatigue performance of the base material. Thus, in this study no way was found to combine good fatigue life with high strain transfer for the spotwelding attachment method.

Figure 8. Strain transfer factors for various flange configurations.

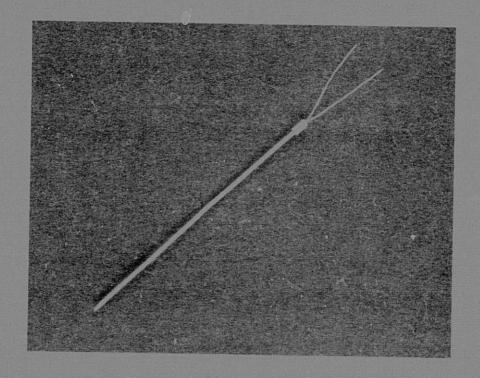
E-30571

Figure 10. Strain gage with indented strain tube.

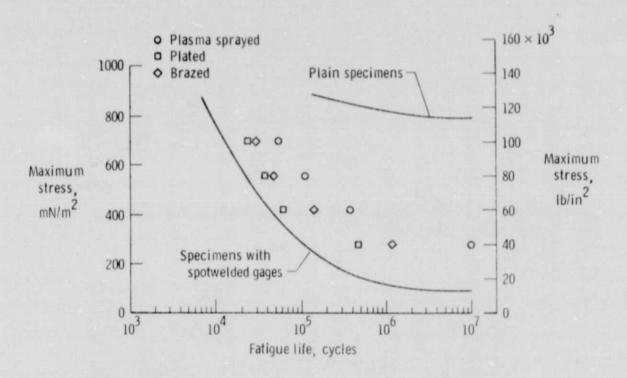
These brazing, plating, and plasma spraying attachment methods were used to attach strain gages to Ti-6Al-4V specimens, and the specimens were subjected to fatigue tests. The results are shown in figure 11. The plating approach offered little improvement in fatigue life. Brazing the gages to the Ti-6Al-4V material proved to be better than plating; it improved the specimens' fatigue life by as much as a factor of 10 over the spotwelded installations. Clearly, however, the best method of installation is plasma spraying. The fatigue life of specimens with plasma sprayed strain gages was as much as 100 times longer than specimens with spotwelded strain gages.

Figure 11. Constant-amplitude fatigue data showing improvement resulting from plasma spraying, plating, and brazing strain gages to Ti-6Al-4V.

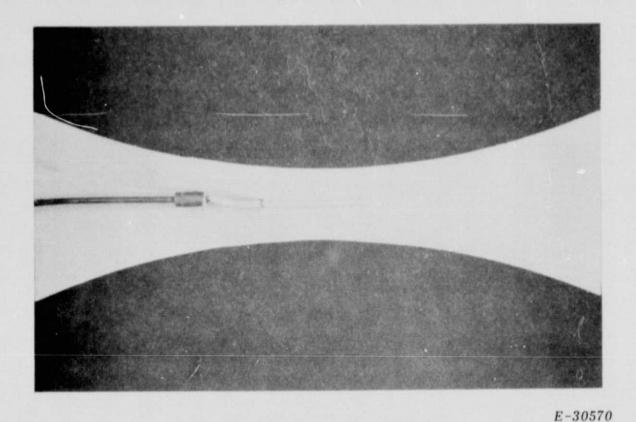
A typical installation of a strain gage that was attached by using plasma spraying is shown in figure 12. The best fatigue performance was achieved by plasma spraying a strain tube without flanges to the base material. A cross sectional view of the installation (fig. 13) shows that the material plasma sprayed becomes built up beneath and around the strain tube.

Figure 12. Weldable strain gage plasma sprayed to Ti-6Al-4V fatigue specimen.

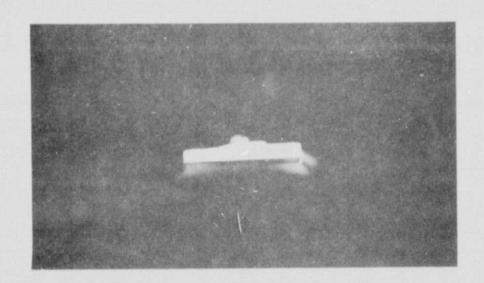
Figure 13. Cross section of weldable strain gage plasma sprayed to titanium fatigue specimen.
